# Ploughs to the rescue!

Recent snowfalls across the country have frequently been claimed to have been the worst for 40 years. That may well be so but in 2010 it would have been so much worse had the snowfall been accompanied by gale force winds as **Maurice Burns** witnessed in 1963. His local Esk Valley branch, now used by the NYMR, was the subject of a huge snowdrift 250 foot long and 15 foot deep that blocked the line and it was six steam locomotives and the last remaining NER wooden snowploughs that came to the rescue.

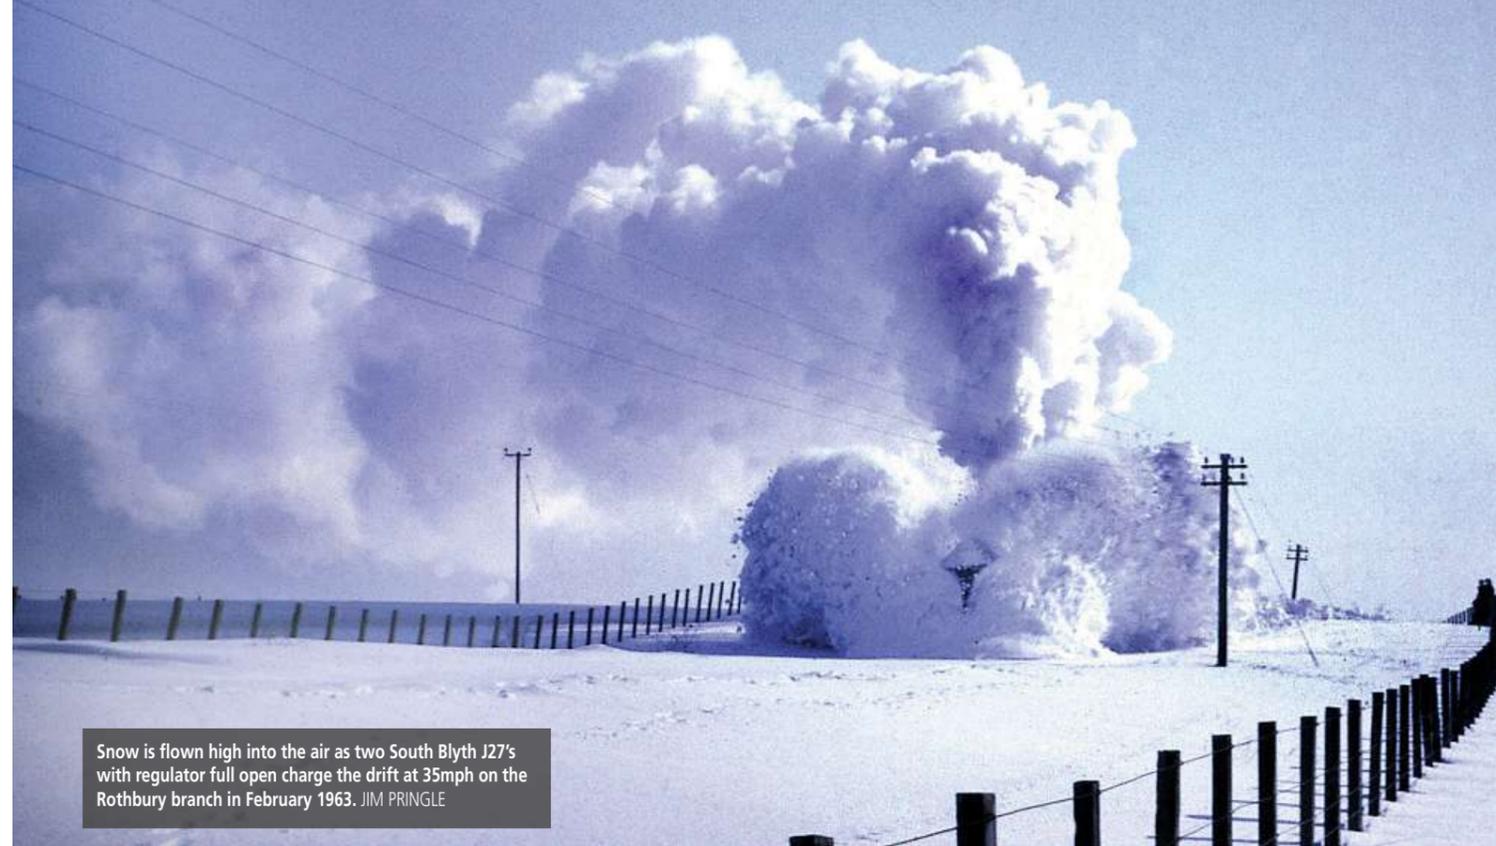
Snow is blown high into the air as two South Blyth J27's with regulator full open charge the drift at 35mph on the Rothbury branch in February 1963. JIM PRINGLE

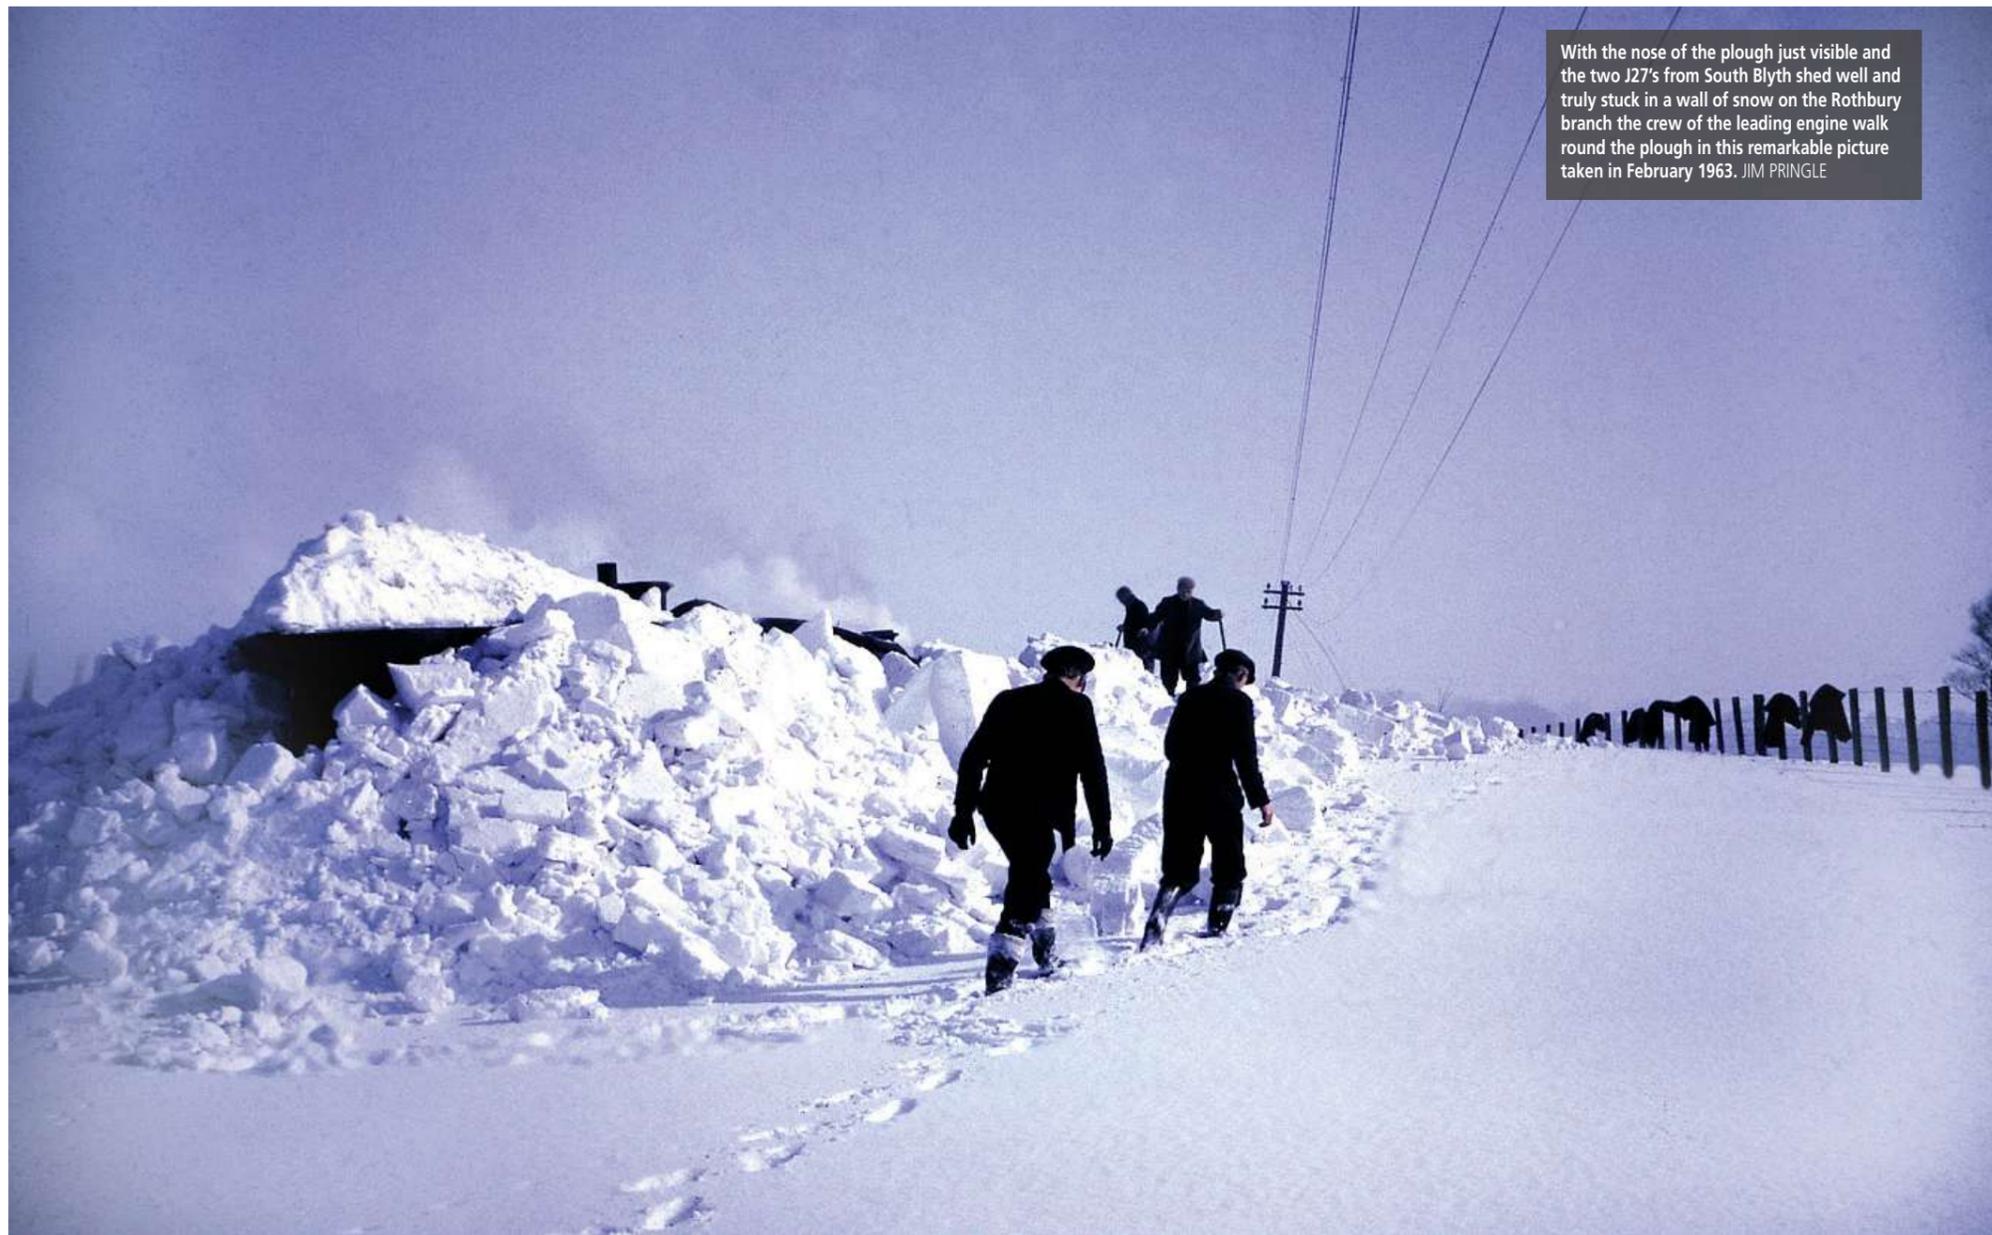
With the nose of the plough just visible and the two J27's from South Blyth shed well and truly stuck in a wall of snow on the Rothbury branch the crew of the leading engine walk round the plough in this remarkable picture taken in February 1963. JIM PRINGLE

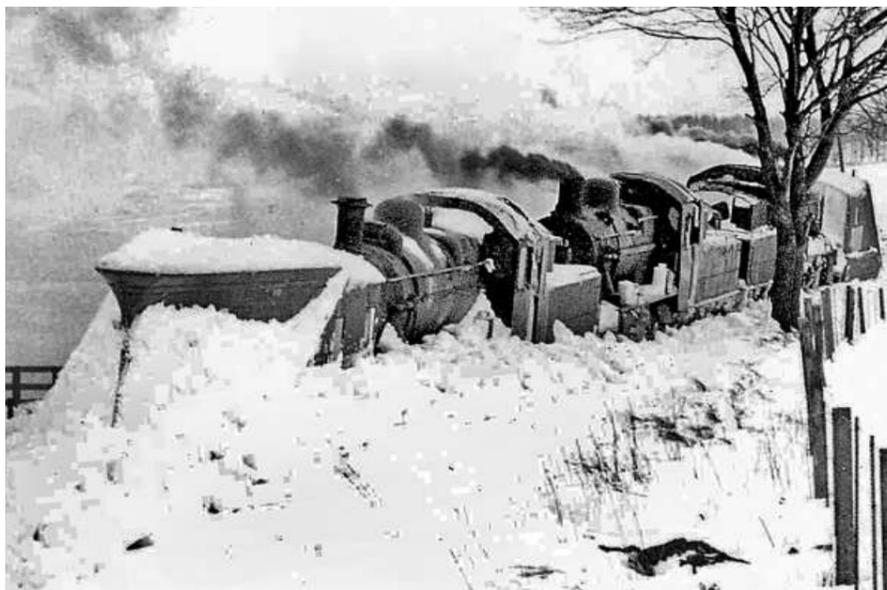
Three Kirkby Stepen BR Standard 2-6-0's and North Eastern Railway snowploughs No 18 and 20 all covered in snow battle through a snowdrift near Merrygill between Kirkby Stepen and Stainmore Summit in 1955. KEN HOOLE COLLECTION

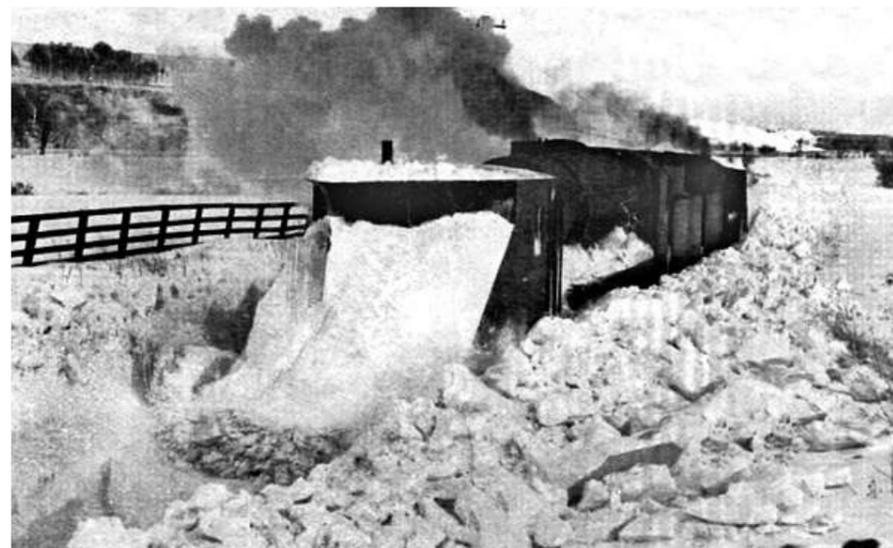
On the second day of snow clearance on the Esk Valley branch Darlington WD's 2-8-0's 90479 and 90593 using North Eastern Railway snowploughs No 18 and 20 clear the line between Battersby and Kildale on 8 February 1963. MAURICE BURNS COLLECTION

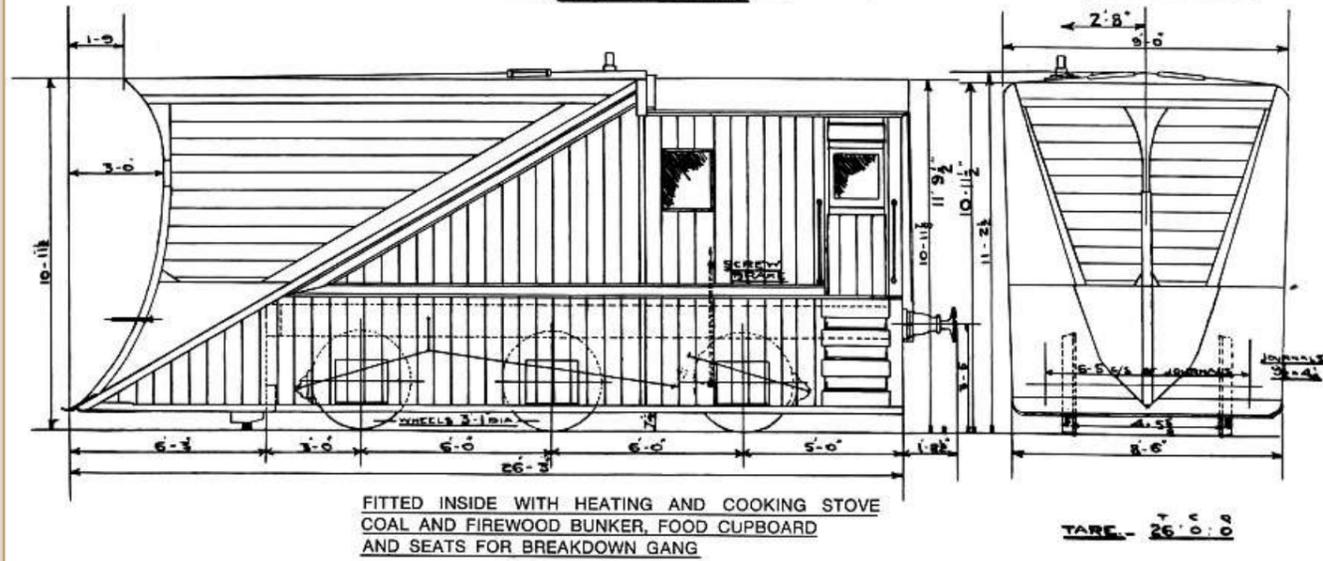
# WOOD SNOW PLOUGH (Nos 18, 19 & 20)

Whitby still had services to Scarborough and Malton and it is believed the Esk Valley was totally blocked for the first time in its history. Prior to the blockage, the ploughs had been over the full length of the line every morning, the normal formation being two Darlington WD 2-8-0s coupled tender to tender with ploughs Nos 18 and 20 at either end. These two ploughs were the last wooden North Eastern Railway ploughs still in use on BR, both built at York works in 1909. The North Eastern Railway diagram shows their method of construction.

(BUILT AT YORK)

BUILT 1909

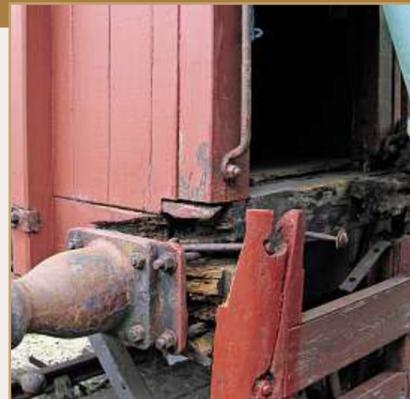
The bufferbeam of NER plough No 18 before rebuilding.

With regard to NYMR resident snowplough No 18, owner Bryan Blundell has, over the past five years, spent a considerable effort and money in restoring this vehicle, replacing in particular many rotten major frame timbers.

Pictures of just one area of work on the rear bufferbeam illustrates the tasks being undertaken.

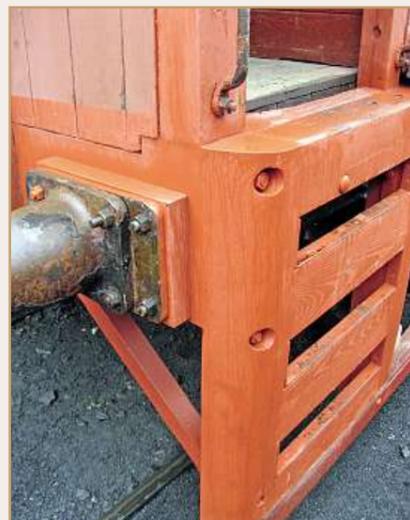
The bufferbeam of NER plough No 18 after rebuilding. BOTH: BRYAN BRUNDELL
